1. Report No. CG-D-21-79	2. Government Accession No. (18) USCG	3. Recipient's Catalog No. (11) (12) 39
4. Title and Subtitle (ACV) Icebreaker Test and Evaluation Program. Volume I. Executive Summary.	5. Report Date July 1978	6. Performing Organization Code (14) CGR-DC-12/78-VOL-1

15. Supplementary Notes This report is an Executive Summary of the work reported in Volume II, "Operational and Engineering Analysis: ACV Icebreaker Test and Evaluation Program."

This document is Volume 1 of a two-part report concerning ACV icebreaking operations conducted by the U.S. Coast Guard on the Illinois and Mississippi Rivers during the winter of 1977-1978. Volume 1, The Executive Summary, presents a comprehensive description of key elements of the test program including an operational summary, results, conclusions and recommendations. Volume 2 of the report, Operational and Engineering Analysis: ACV Icebreaker Test and Evaluation Program, provides detailed operational and engineering information, including complete data on testing procedures, analysis and results (Reference 7).

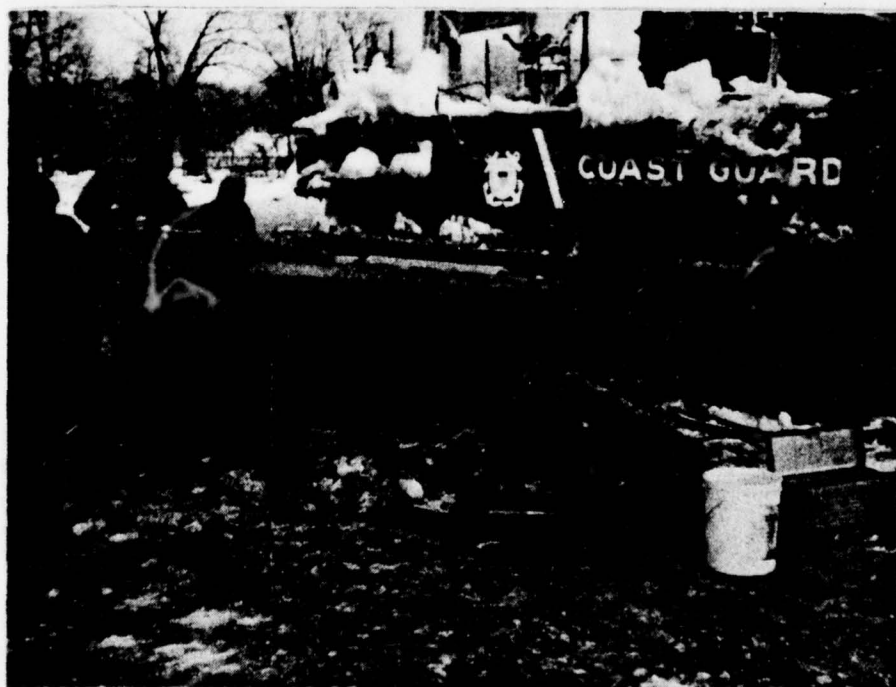
MACKACE SEGMENT REPAIR

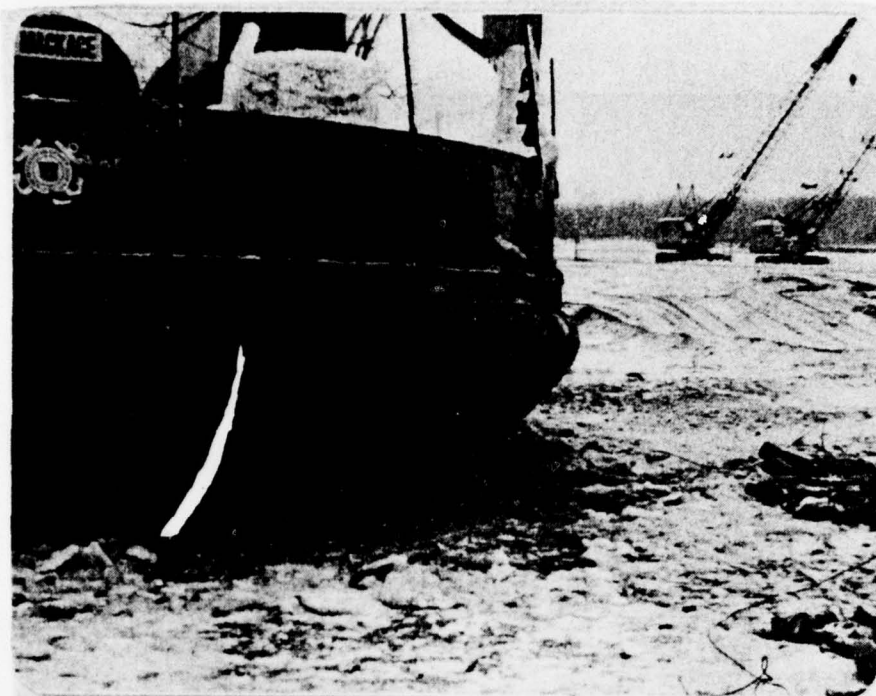
MACKACE ON HOVER SHOWING RIP IN SEGMENT

Of the many design criteria developed through the test and evaluation program, one of the most important was the determination of the type of skirt fabric that can best withstand the impact of river ice. The 60 oz. per sq. yard single weave, nylon fabric bonded with natural rubber that was used on the MACKACE ACV was unable to survive the ice environment. The LACV-30 used a two-ply material of several different weights, including 60 oz. per sq. yd., which was considerably more durable than the single-weave fabric.

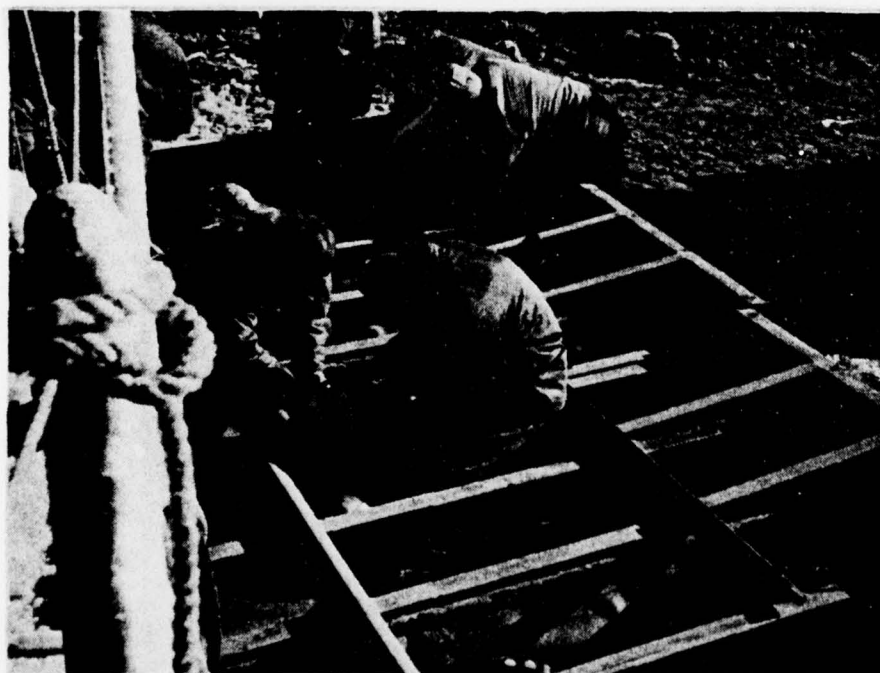
MACKACE REPAIR OF SEGMENT DAMAGE

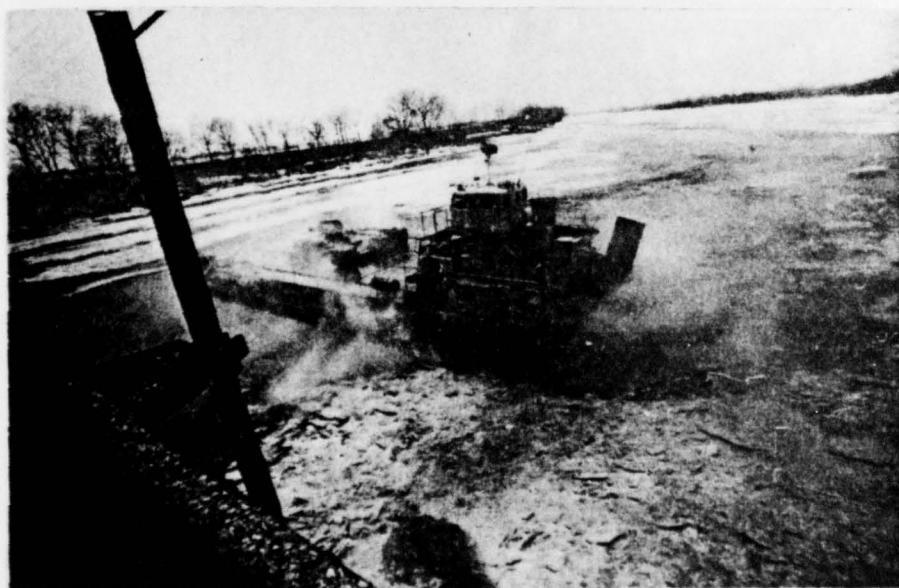
LACV-30 BREAKING ICE FOR FLOOD  
CONTROL KANKAKEE RIVER

The LACV-30 was deployed for a flood control operation on the Kankakee River (Illinois) for 18 days. The LACV-30 effort was highly successful and, according to the U.S. Army Corps of Engineers, Chicago District, it was responsible for averting possible serious flooding in the lower Kankakee River area.
